| <b>Customer:</b> SAFEWARE | <b>Customer Contact:</b> |
| <b>Product:</b> ICM-42670-P | <b>Package Type:</b> LGA |

SAFEWARE returned one unit for failure analysis. The reported failure symptom was that the gyro output was fixed at -32768. (1F/130) Table 1 summarizes the details of the returned unit.

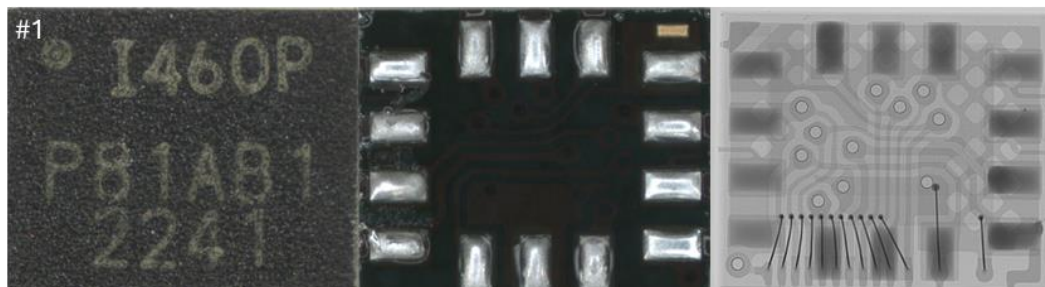
**Figure. 1: Visual and X-ray inspection results**

Visual and X-ray inspections were performed on the returned device, and no abnormalities were found. Figure 1 shows the condition of the returned unit upon receipt.

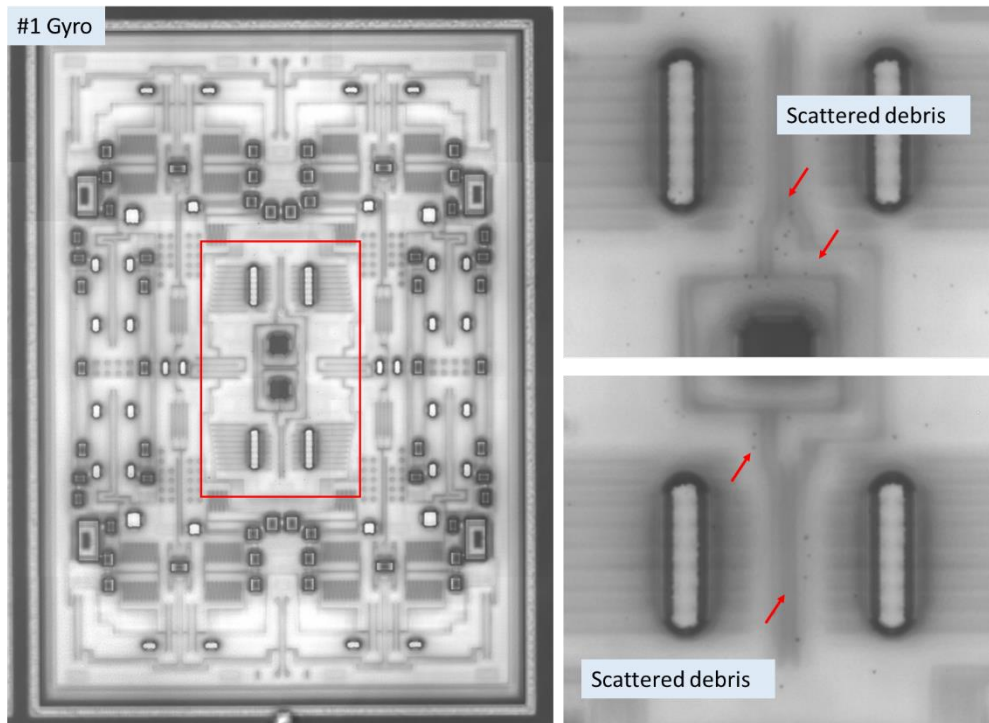
**Figure 2: IROM images**

Unit #1 was selected for removal of the molding compound to enable IROM inspection of the MEMS structure. Scattered debris was observed inside the gyro cavity during the IROM inspection, as shown in Figure 2.

- After removal of the molding compound, scattered silicon debris was observed inside the gyro cavity during IROM inspection. Scattered debris and hit marks were observed during OM and SEM inspections as well.

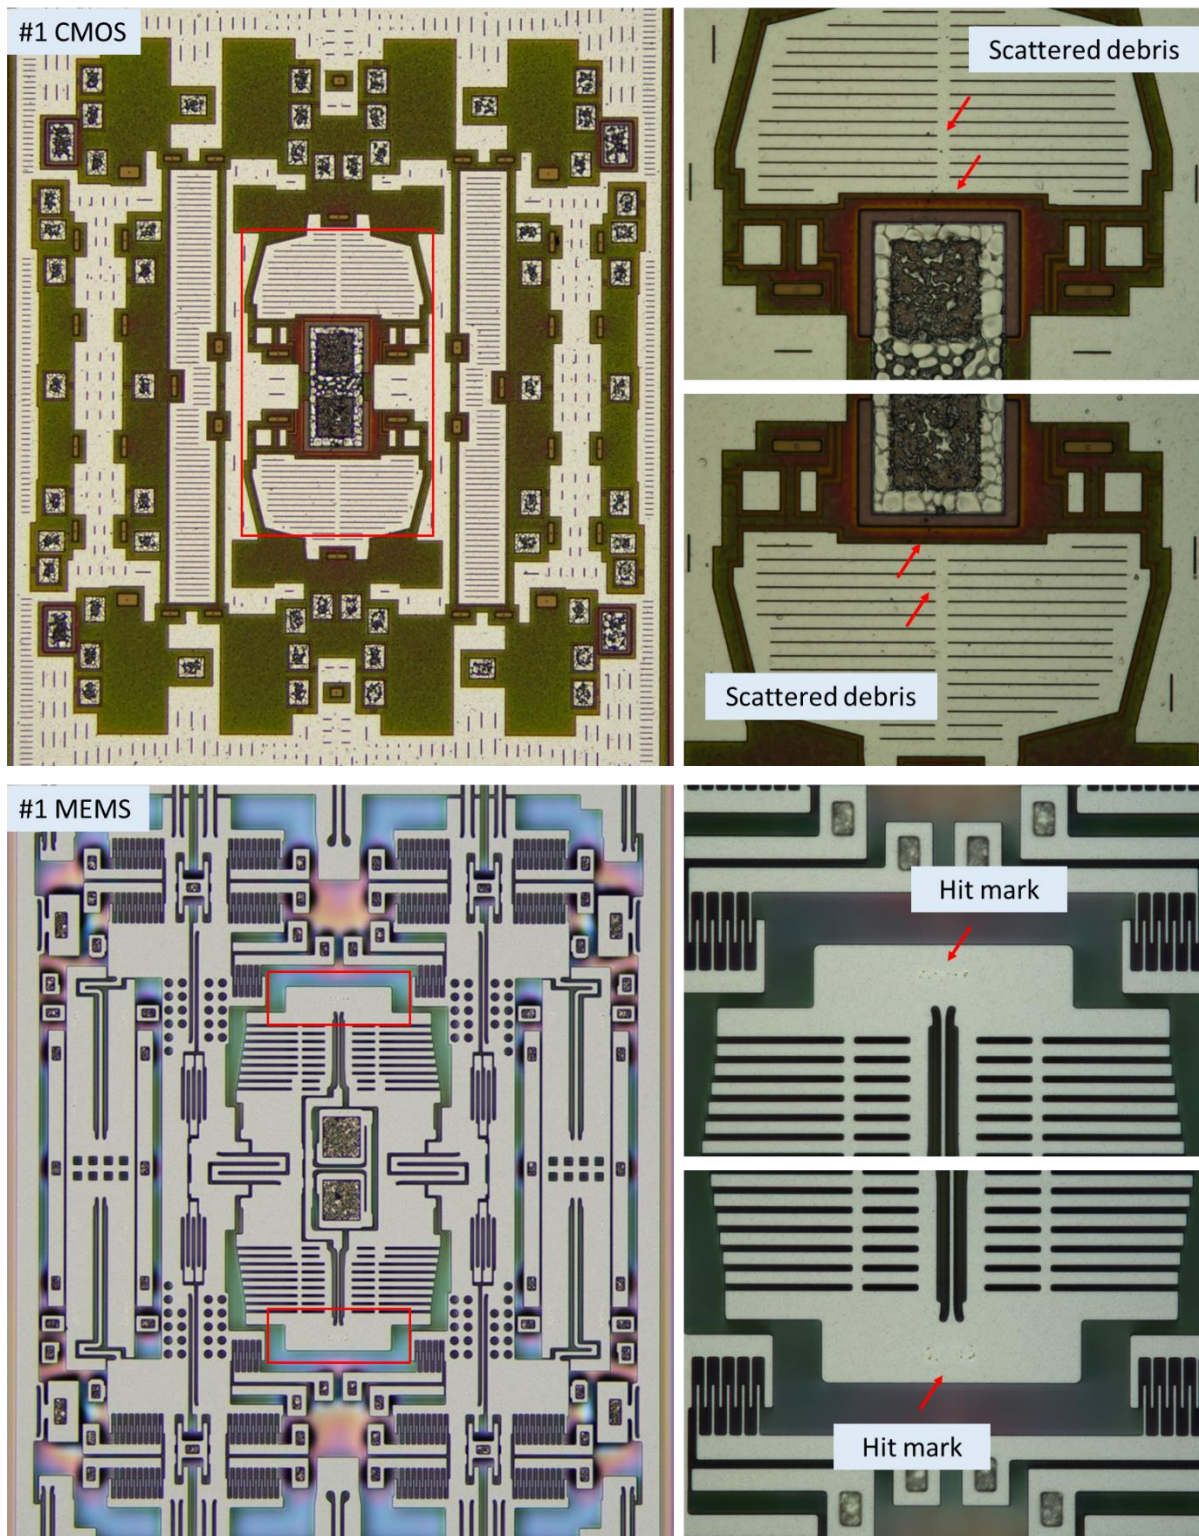
Figure 3: OM images

Subsequently, Unit #1 underwent separation of MEMS and CMOS for inner structure inspection. Scattered debris and hit marks were observed on both MEMS and CMOS structures during OM and SEM inspections. Based on the physical analysis, the returned device is considered to have experienced mechanical overstress events. (Figures 3 and 4)

- Based on analysis conducted above, the returned device is considered to have experienced mechanical overstress events. TDK-InvenSense would like to recommend that the customer avoid any unexpected stress that may damage the part.
